The Effect of Cavity Design on Fracture Resistance and Failure Pattern in Monolithic Zirconia Partial Coverage Restoration - An In vitro Study

Aim: To evaluate the fracture resistance and failure pattern of three different cavity designs restored with monolithic zirconia.

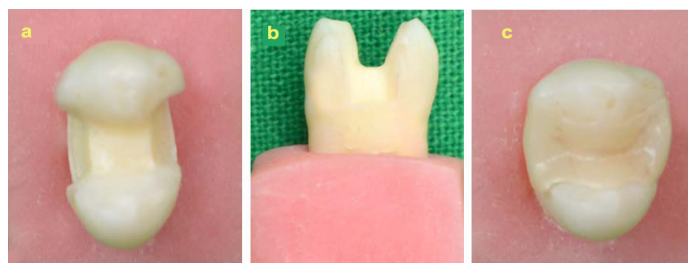
[Table/Fig-1]: Group II - MOD Inlay cavity preparation: a) Occlusal view; b) Proximal view; c) Zirconia restoration.

Among 40 teeth, 10 teeth were randomly selected for the control group, i.e., Sound teeth (Group I), remaining teeth were divided into three groups based on the cavity designs. MOD cavities were prepared using FG 271 and FG169L carbide burs (SS White, Lake wood, USA). In Group II-MOD Inlay, cavity preparations were done with occlusal cavity width kept at 1/3rd the intercusp distance, the cavity pulpal floor depth was 1.5 mm at the central groove area and each wall with a taper of 3°. In the proximal box, gingival seat was placed 1 mm above the cemento-enamel junction and mesiodistal width of the seat was kept as 1 mm [Table/Fig-1]. In Group III-Partial Onlay, preparation were similar to Group II but the palatal cusp was reduced by 1.5 mm with a collar of 1 mm [Table/Fig-2]. In Group IV -Complete Onlay preparations were similar to Group III with palatal cusp reduction by 1.5 mm with a collar of 1 mm width and buccal cusp reduction of 1 mm with collar of 1 mm [Table/Fig-3,4].

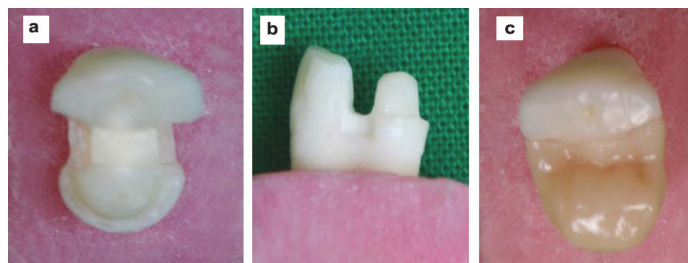
[Table/Fig-2]: Group III - MOD Onlay with buccal cusp preservation and palatal cusp reduction (Partial Onlay): a) Occlusal view; b) Proximal view; c) Zirconia restoration.

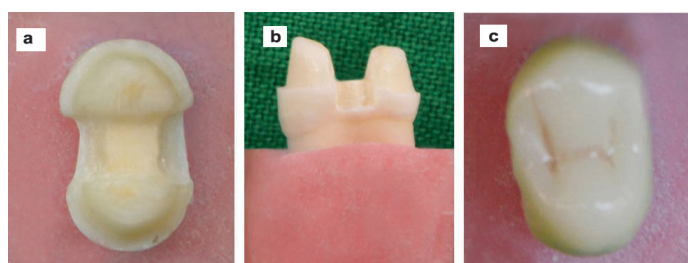
[Table/Fig-3]: Group IV - MOD Onlay with buccal and palatal cusp reduction (Complete Onlay): a) Occlusal view; b) Proximal view; c) Zirconia restoration.

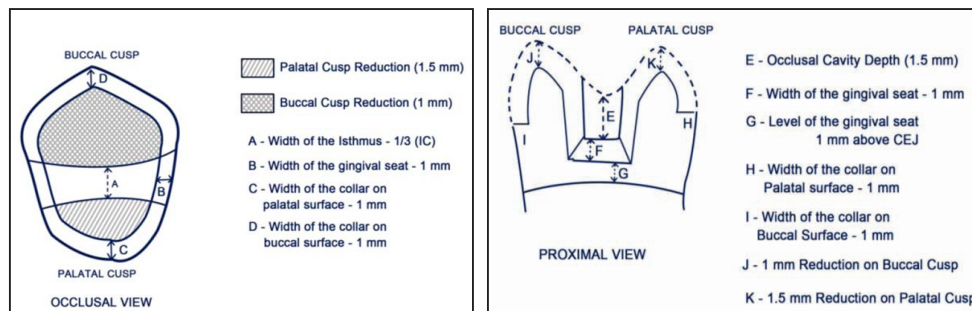
[Table/Fig-4]: Schematic diagram of occlusal and proximal view of Complete Onlay (Group IV). IC-Intercusp distance; CEJ- Cementoenamel Junction

In the present study, the cavities were more conservative considering the high fracture toughness and superior properties of zirconia. The occlusal cavity width was maintained at 1/3rd the intercuspal distance and occlusal depth of 1.5 mm from the central groove. Palatal cusp was reduced by 1.5 mm in both Partial Onlay and Complete Onlay groups and buccal cusp by 1 mm. The gingival seat was located 1 mm above the CEJ as the margins placed below CEJ affected the stability of the restorations and also bonding.

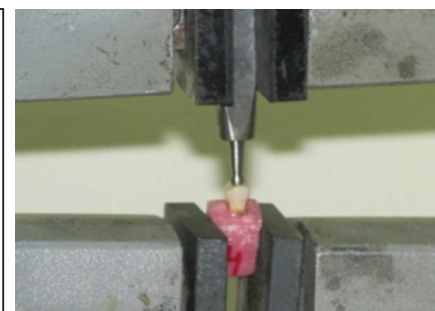
[Table/Fig-5]: Load application using Universal Testing Machine (UTM) for testing fracture resistance.

The samples were stored in water at 37°C for 21 days. The fracture resistance of the samples was tested using UTM (Instron, UK). The load was applied on the center of the buccal cusp slope at an angle of 30° to the long axis of the tooth with a steel ball of diameter 3.5 mm and a crosshead speed of 0.5 mm per minute [Table/Fig-5]. The applied force was measured in Newtons (N).

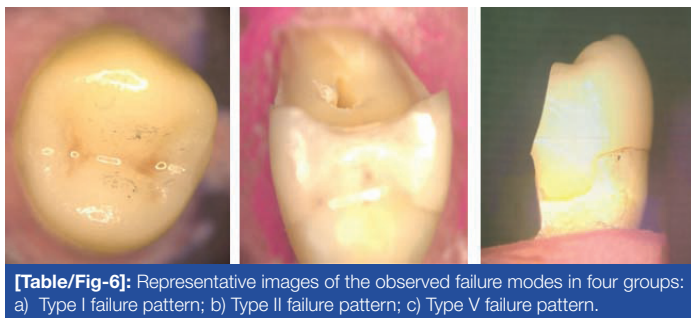
[Table/Fig-6]: Representative images of the observed failure modes in four groups: a) Type I failure pattern; b) Type II failure pattern; c) Type V failure pattern.

All the fractured specimens were observed under stereomicroscope (2X magnification) to visualize the fracture lines in the tooth and the restoration [Table/Fig-6].

- Type I - No visible fracture in the restoration and tooth;
- Type II - No visible fracture in the restoration but fracture in the tooth;
- Type III - Fracture in the restoration only;
- Type IV - Fracture in the restoration and the tooth above CEJ;
- Type V - Fracture in the restoration and the tooth below CEJ.
